# Treatment Strategies

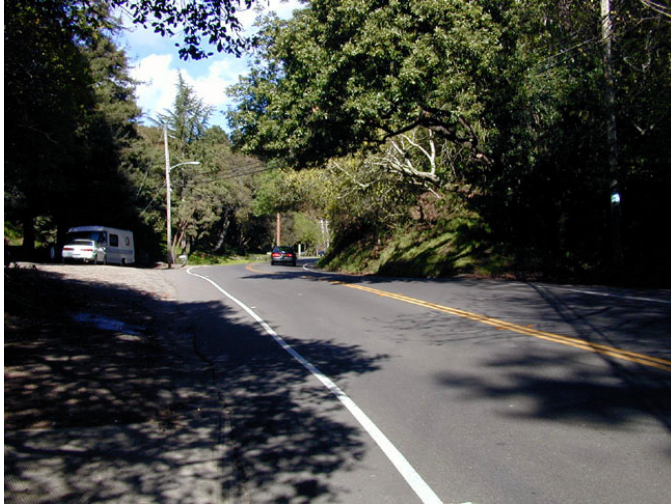
Along Claremont Avenue near the bottom of the canyon. Claremont Creek in culvert on left.

Moist oak woodland slope with understory ferns and herbaceous plants.

No Hazard Reduction Needed.

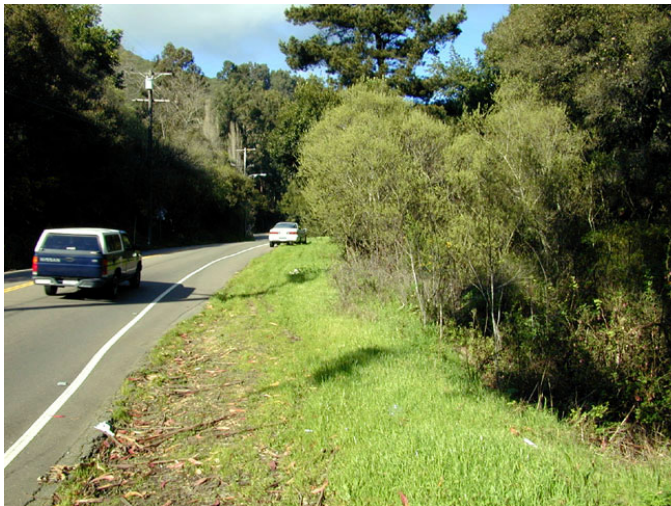
Along Claremont Avenue near the bottom of the canyon. Claremont Creek on right.

Riparian corridor on right side of picture. Willow and other streamside vegetation.

Treat grassy road edge on top of bank only. Do not treat creek area.

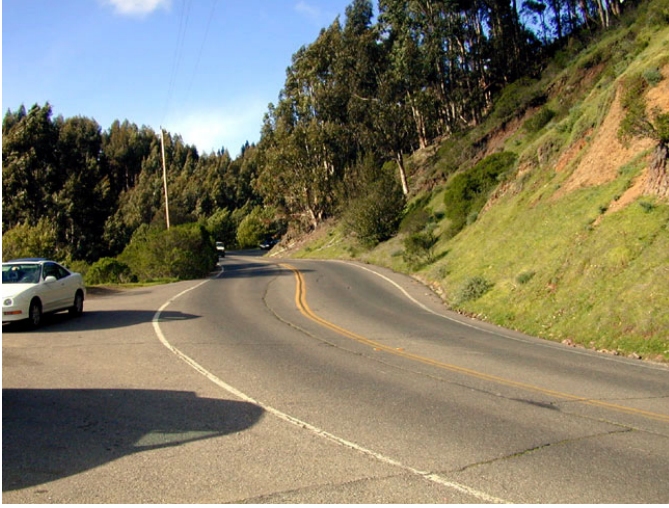
Grizzly Peak north of Claremont Avenue.

Steep rocky slopes with thin soil and little vegetation.

Treat only flashy grass fuels at toe of slope. Do not disturb shrubs or other vegetation that helps stabilize the slope.

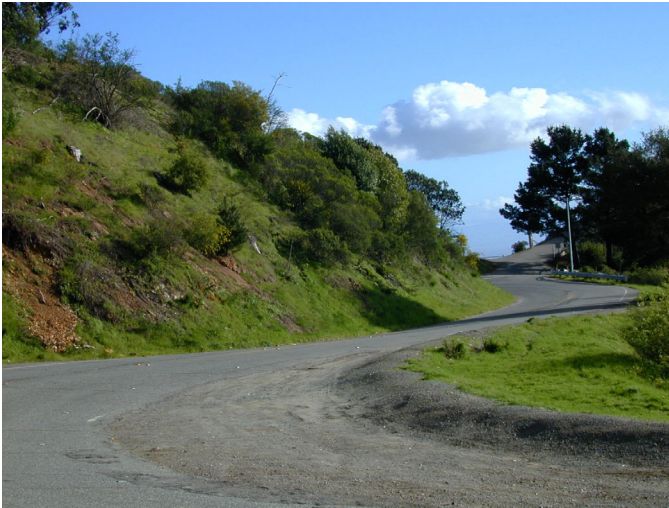
Grizzly Peak near Marlborough Terrace.

Steep rocky slopes with thin soil and little vegetation.

Treat only flashy grass fuels at toe of slope. Do not disturb shrubs or other vegetation that helps stabilize the slope.

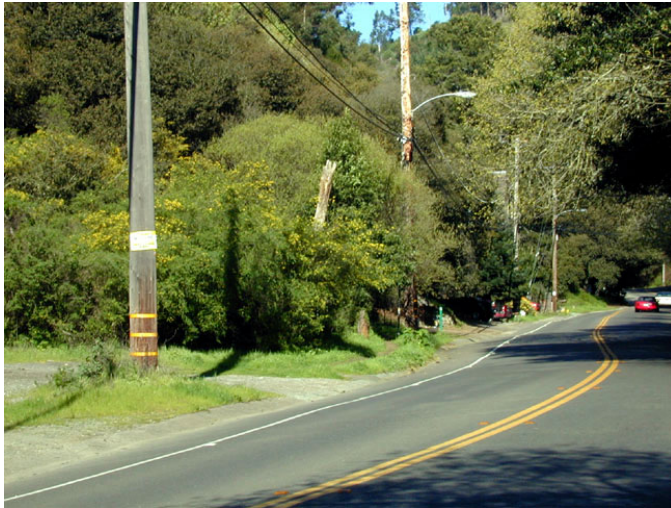
Lower Claremont Avenue near homes

Mixed shrub including French broom, coyote brush and blackberry.

Treat to break up continuity and reduce overall fuel load.

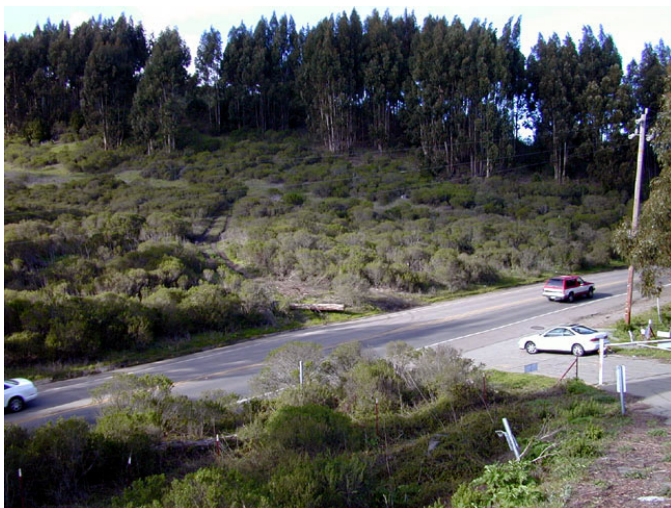
Grizzly Peak Drive north of Claremont Avenue near Chapparal Hills.

Dense stand of mature coyote brush.

Treat to break up continuity and reduce overall fuel load.

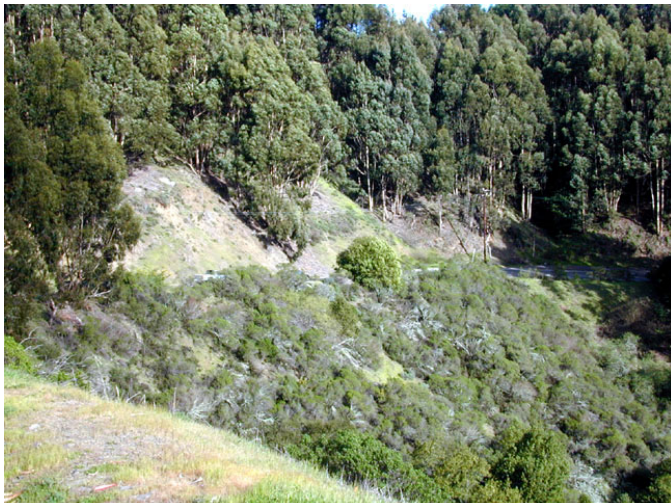
Along Grizzly Peak north of Claremont Avenue.

Dense stand of mature coyote brush downslope from road. Slope > 30%.

Treat to break up continuity and reduce overall fuel load. Treatment should knock down or cut off tops of shrubs. To help maintain slope stability, do not disturb rootballs or remove entire plant.

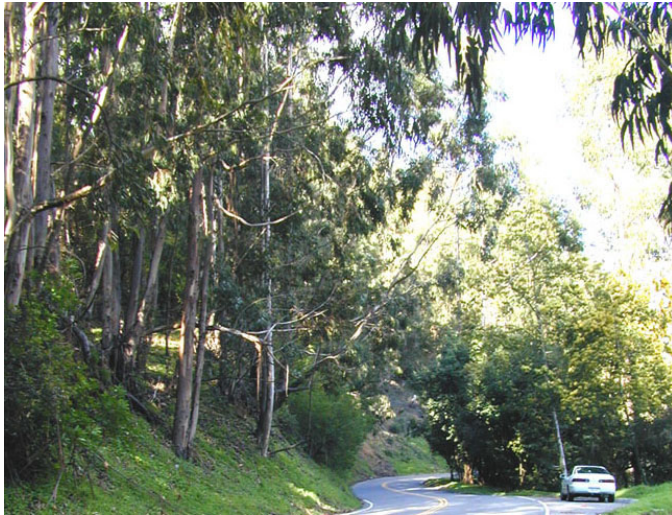
Treated Eucalyptus stand.

No further hazard treatment needed.

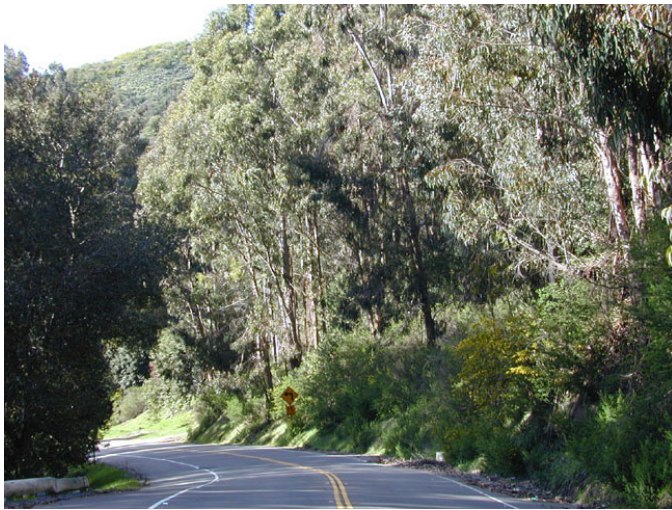
Second growth Eucalyptus stand.

Treat to remove ladder fuels and reduce overall stand density.
